# Unalaska Department of Public Safety Building Geotechnical Engineering Report

Project No. 181209

PND Engineers, Inc. 1506 West 36th Avenue Anchorage, AK 99503

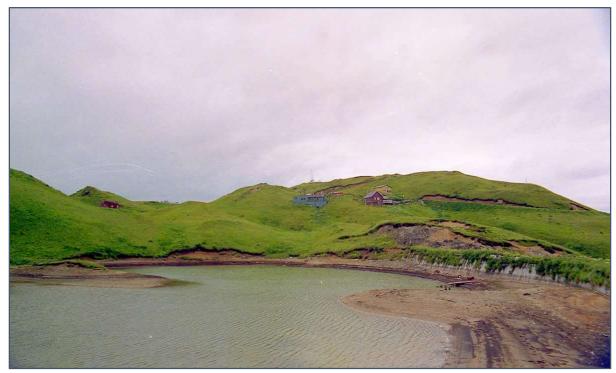
Figure 2-1. Proposed Site Prior to Fill Placement (pre-1989)

Historically, the proposed location was a shallow lake as shown in Figure 2-1. This lake was filled during construction of the UniSea Port Development project in 1989 using excavated material from that project.

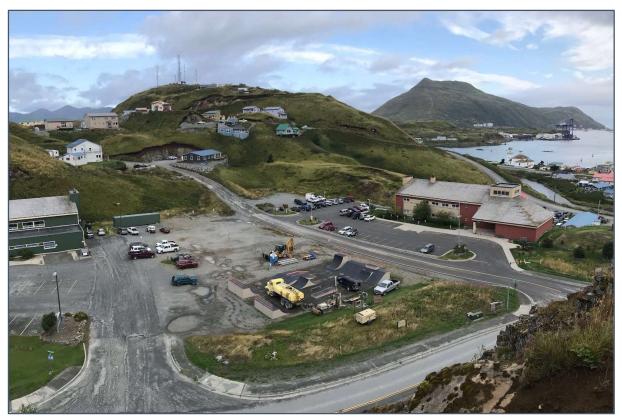
Figure 2-2. Existing Conditions of Proposed Project Site

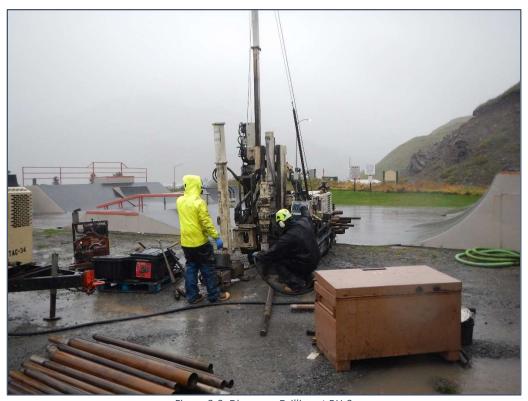
Figure 2-3. Discovery Drilling at BH-3

Generally, the Modified SPT testing was performed at 2.5-foot intervals beginning 2 feet below ground surface (bgs) and continuing to a depth of 10 feet bgs. Testing was performed at 5-foot intervals thereafter until refusal of the sampler or drilling action indicated that bedrock had been encountered. Refusal is defined as requiring more than 50 hammer blows to advance the sampler past a single 6-inch interval. Upon reaching bedrock, the sampler was retrieved from the borehole and an NQ3 rock core barrel was installed on the drill and advanced an additional 10 feet into bedrock. The recovered soils were field classified following the United Soils Classification System (USCS) according to ASTM D2487 and representative samples were shipped to PND's Anchorage Soil-Material Lab for field verification and lab testing. Soil types and depths are described in Section 3.3.

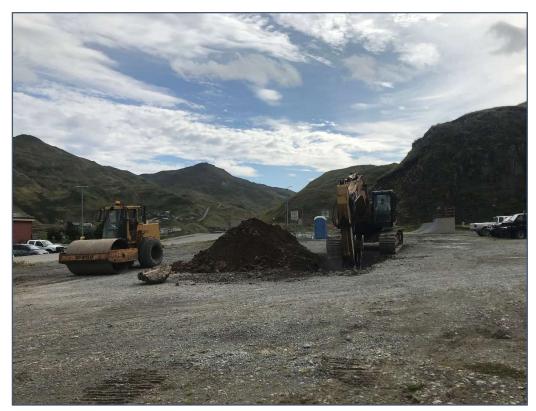
Figure 2-4. Test Pit Excavation

Geotechnical test pit exploration was performed by Northern Alaska Contractors, LLC using a CAT 330 tracked excavator. The Contractor made special effort to preserve the vegetative mat and top soil during excavation activities, where present. The salvaged vegetative mat was laid over the disturbed area and lightly compacted using the underside of the excavator bucket once the test pit was backfilled to the appropriate elevation. In areas where vegetation was not present, the Contractor used a combination of the underside of the excavator bucket and a vibratory compactor for compaction while backfilling the test pits.

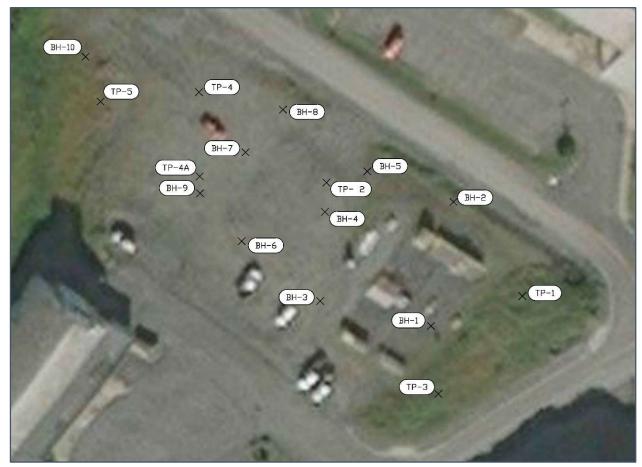
Figure 3-3-1. As-Built Borehole Locations

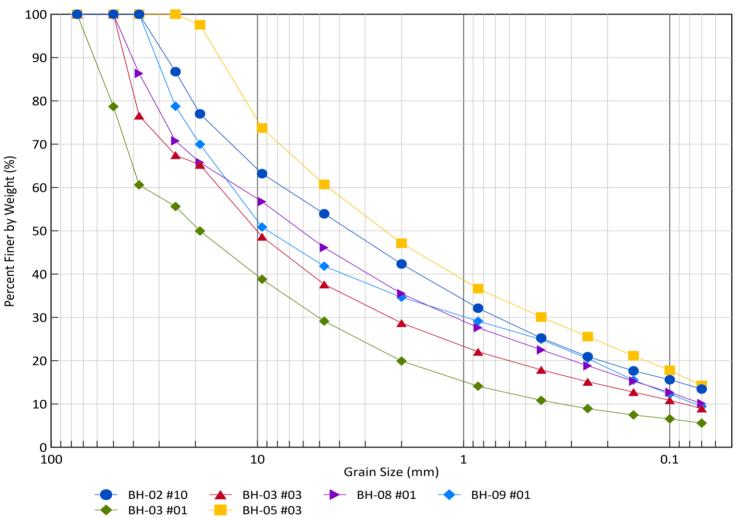
Sample				Gra	dation (	(%)		
Borehole	#	From	То	Laboratory Classification	Gravel	Sand	Fines	D50	P10
BH-02	10	35.5	36	sGM	46.1	40.5	13.5	3.5	42.3
BH-03	01	5.5	6	(GW-GM)s	70.9	23.6	5.6	19.0	19.9
BH-03	03	10.5	11	(GP-GM)s	62.4	28.7	9.0	10.1	28.7
BH-05	03	8	8.5	gSM	39.3	46.4	14.2	2.4	47.1
BH-08	01	2.5	3	s(GP-GM)	53.9	36.0	10.0	6.1	35.5
BH-09	01	3	3.5	s(GP-GM)	58.2	32.4	9.4	8.9	34.6

Full sieve stack gradations were performed on select coarse grained materials. Visual-Manual classifications and moisture contents were performed on select fine-grained materials. The samples chosen for testing were representative of the strata found at the site
